Impacts of Water Supply and Sanitation in Three Rural  
Guatemalan Communities.

1996

# IMPACTS OF WATER SUPPLY AND SANITATION IN THREE RURAL GUATEMALAN COMMUNITIES

A research paper submitted in conformity with the requirements  
for the degree of Master of Arts  
Graduate Department of Geography  
University of Toronto

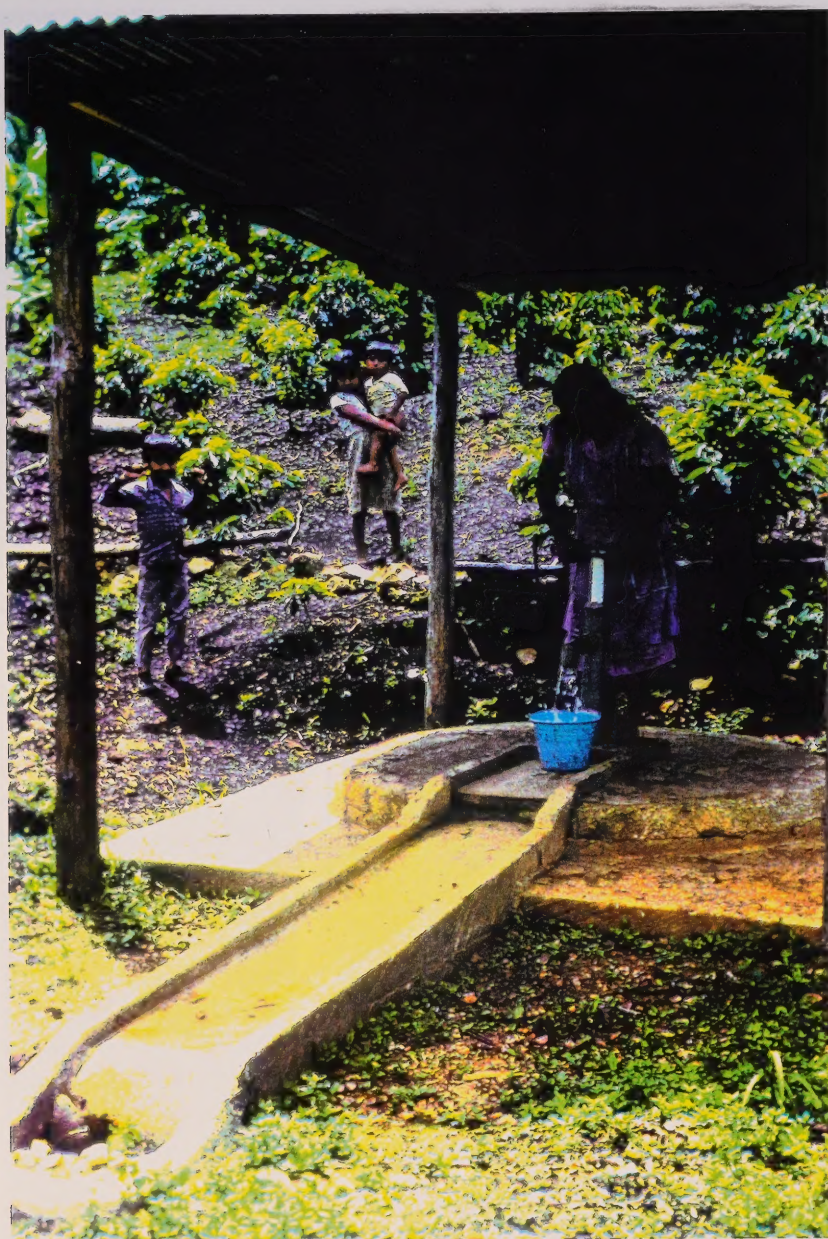
Figure 4. "Maya" brand pump used in Santa Elena

The village of Santa Elena has been provided with two community groundwater pumps one located in the center of the scattered houses and the second at the periphery. The Guatemalan-made “Maya” brand pumps sit on a cement well cover that has a collection trough to drain excess water from the immediate pump area (figure 4). Sheet-metal roofs cover the pumps. The pump located in the center of the village had been non-functional for 5 weeks prior to, and remained inoperable at the time of, my visit. This was due to a broken part, damaged during maintenance by the local villagers.

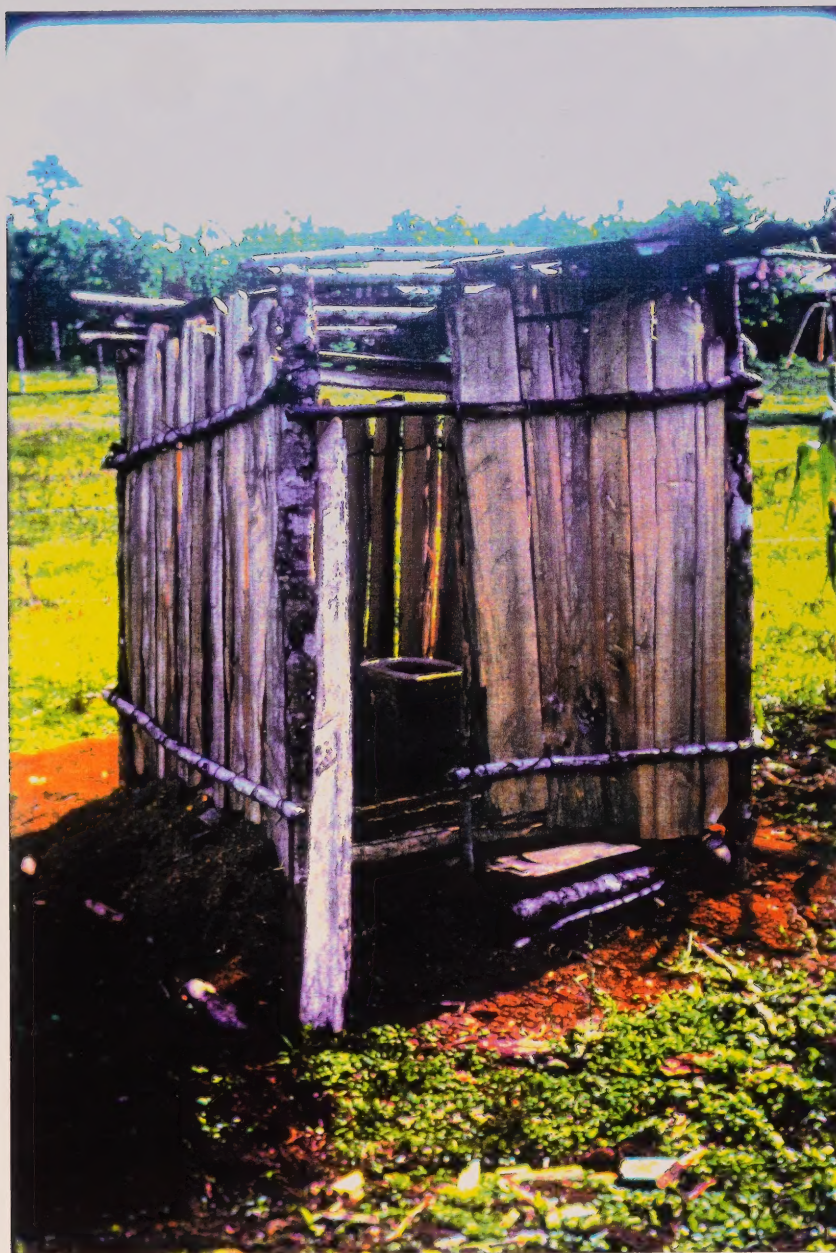
Figure 4. Simple pit latrine in Yalambojoch

Two different latrine systems have been implemented in the communities. Simple unventilated pit latrines (figure 5) have been instituted in Yalambojoch and Yulaurel. Since the water is not drawn from the groundwater table the pits will not contaminate the local water supply. As the villages are quite isolated the threat to neighbouring villages' water supply is minimal. The latrines consist of an unlined pit 2-3m in depth covered with a 1.2m x 1.2m cement floor and a cement pedestal approximately 40cm high. These latrines replace older versions with wooden floors and seats.

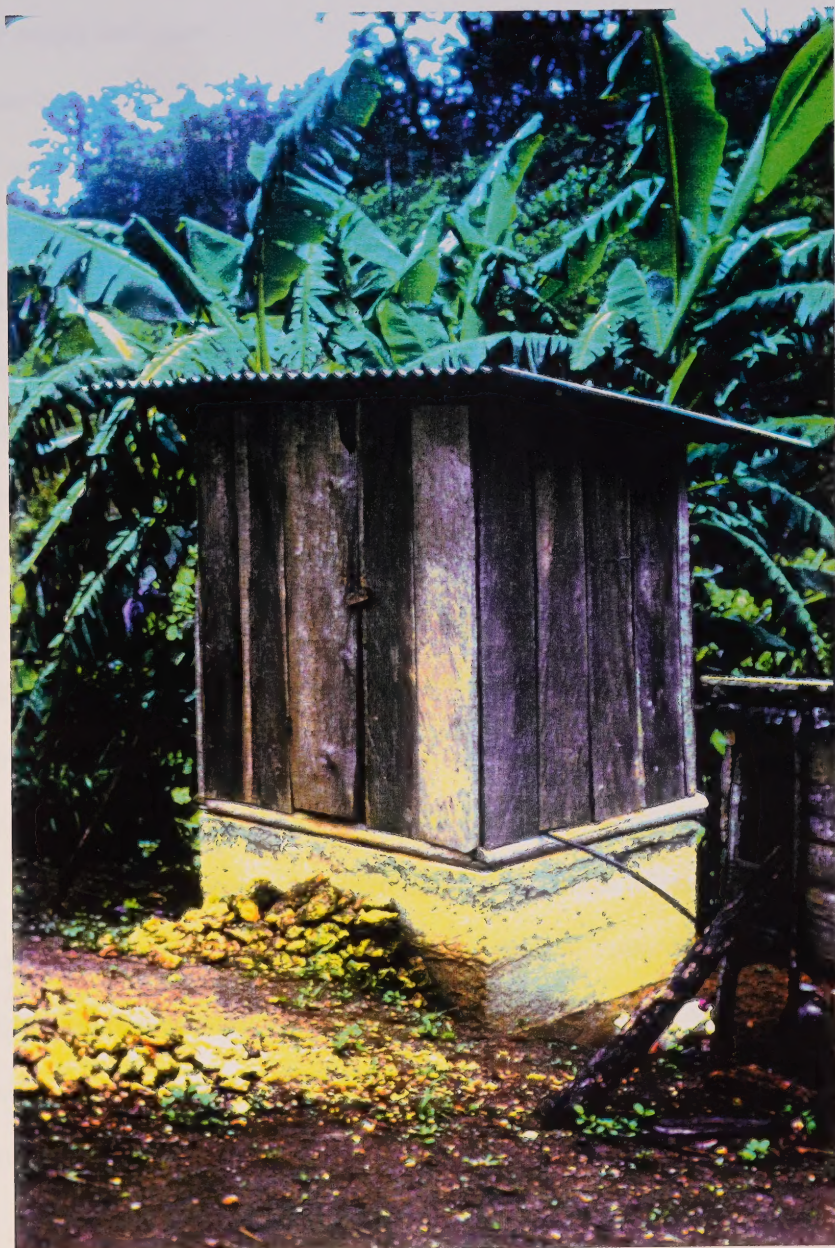
Figure 6. Composting latrine (letrina abonera) in Santa Elena

Where the groundwater table is high, within 300cm of the surface, it is recommended that latrines be built above ground (Mara 1984). Santa Elena has received composting latrines (letrina abonera)(figure 6) that sit above ground thus they do not affect the village's groundwater source. The composting toilets are dry latrines that have two collection compartments. Excreta collects in the compartment while a small urinal at the front of the seat is drained via a plastic tube to a collection jug which is then used for watering plants. When one compartment is full it is left to compost for 6-8 months while the other side is used. To aid in the composting process residents are required to sprinkle ash from the kitchen fire in the latrine every few days. Compost is to be used as fertilizer for shrubs and plants. Latrine coverage for all three villages is 100% of the households.

the latrines and would most likely be used for fertilizer. An instance of a pop can being thrown into the composting toilets was also noted. These practices reduce the effectiveness of the latrines both in terms of the health benefits received and the possibility of using the waste for compost.

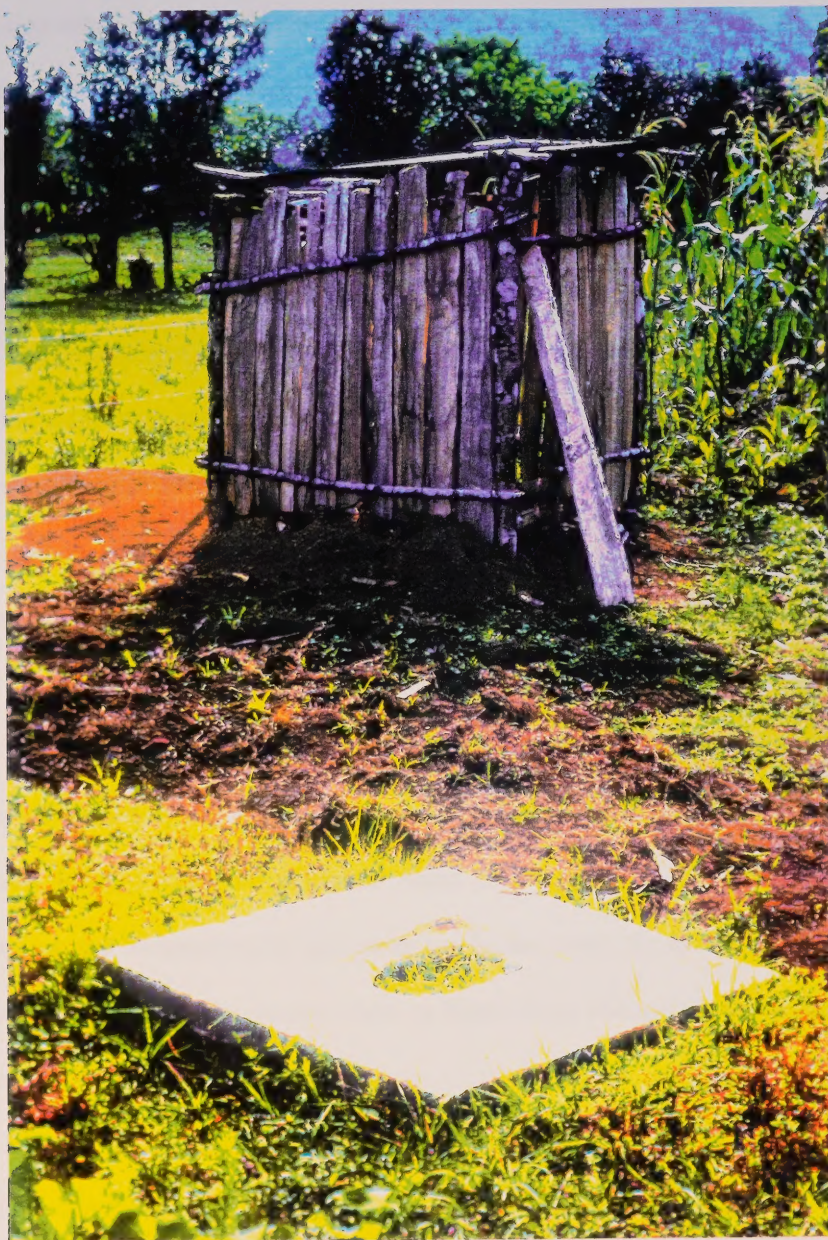
Figure 8. Latrine after pit collapse

In an attempt to ensure 100% latrine coverage for the villages simple standard designs used throughout the developing world were chosen and instituted en masse. The use of these standard designs has resulted in some difficulties with the latrines. In Yalambojoch some of the latrines located at the base of a mountain slope have had the ground crumble beneath the floor resulting in collapse of the base of the latrine so the

cement floor can not be used (figure 8). This appears to be a problem with about 5-10 latrines and usually occurs in the rainy season. At present the problem is dealt with by placing logs either directly under the cement seat or under the floor itself. This seems to be successful in maintaining the stability of the floor. Some in the village feel above-ground composting toilets would be more appropriate. Mention was made of this problem also in Yulaurel though no collapse of latrines has occurred. By providing latrines to all residents some overlap has occurred and two houses noted in Yulaurel have both new and old latrines. Most suggested that the cement floor of the new latrines was superior as it does not rot but many were indifferent to the materials used and did not see the new latrines as a great improvement over the old ones.
